**Report No.: VS-TV-130129-01**

# Test Report

Product Name	<b>IVX-1000-ICY</b>
Applicant Name	<b>Vecow Co., Ltd.</b>
Applicant Address	<b>3F., No. 10, Jiankang Rd., Zhonghe Dist., New Taipei City 23586, Taiwan</b>

Test Report NO.	VS-TV-1130129-01
Applicant Name	Vecow Co., Ltd.
Product	High-Performance Fanless System
Model	IVX-1000-ICY
CPU	13th Gen Intel® Core™ i7-13700TE@1.10GHz
RAM	INNODISK DDR5 4800 32GB W/T SODIMM x 2
SSD	INNODISK 2.5" SATA SSD 3TE7 512GB x 6
Quantity	1 PCS
Date of Test	Jan 19 ~ 26, 2024
Test Standard	IEC 61373 Category 1- Class B-2010

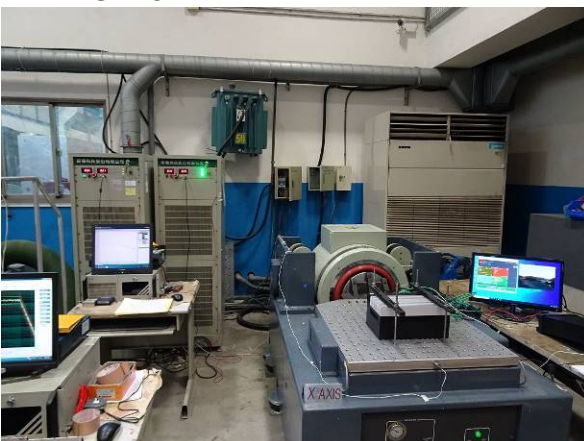
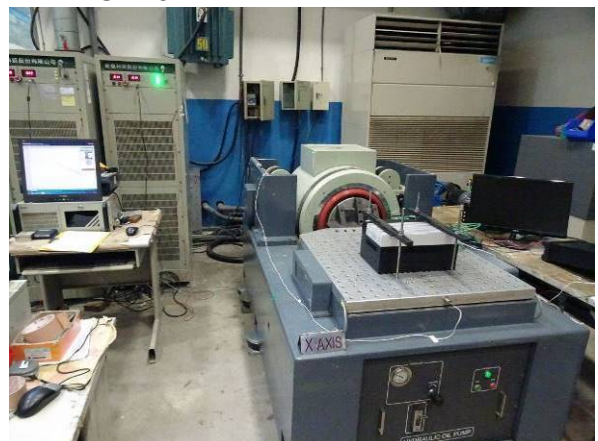
FIG 1.1: X axis direction mounted

FIG 1.2: X axis direction mounted

FIG 1.3: X axis direction mounted

FIG 1.4: X axis direction mounted

FIG 1.5: X axis direction mounted

FIG 1.6: X axis direction mounted

<p>Vibration Axial: X, Y, Z</p> <p>Single Axis Time: 10 minutes</p> <p>Total Time: 30 minutes</p> <p>FIG 1.1 ~ 1.6: X axis direction mounted</p> <p>FIG 2.1: X axis test screen</p> <p>FIG 3.1 ~ 3.6: Y axis direction mounted</p> <p>FIG 4.1: Y axis test screen</p> <p>FIG 5.1 ~ 5.6: Z axis direction mounted</p> <p>FIG 6.1: Z axis test screen</p>			Axial:	Vertical (Z Axis)	Longitudinal (Y Axis)	Longitudinal (X Axis)	Acceleration:	1.01 m/s <sup>2</sup> RMS	0.45 m/s <sup>2</sup> RMS	0.700 m/s <sup>2</sup> RMS	PSD:	0.0301 (m/s <sup>2</sup> ) <sup>2</sup> /Hz ( 5 ~ 20 Hz ) -6dB / octave ( 20 ~ 150 Hz )	0.0060 (m/s <sup>2</sup> ) <sup>2</sup> / Hz ( 5 ~ 20 Hz ) -6dB / octave ( 20 ~ 150 Hz )	0.0144 (m/s <sup>2</sup> ) <sup>2</sup> / Hz ( 5 ~ 20 Hz ) -6dB / octave ( 20 ~ 150 Hz )
Axial:	Vertical (Z Axis)	Longitudinal (Y Axis)	Longitudinal (X Axis)												
Acceleration:	1.01 m/s <sup>2</sup> RMS	0.45 m/s <sup>2</sup> RMS	0.700 m/s <sup>2</sup> RMS												
PSD:	0.0301 (m/s <sup>2</sup> ) <sup>2</sup> /Hz ( 5 ~ 20 Hz ) -6dB / octave ( 20 ~ 150 Hz )	0.0060 (m/s <sup>2</sup> ) <sup>2</sup> / Hz ( 5 ~ 20 Hz ) -6dB / octave ( 20 ~ 150 Hz )	0.0144 (m/s <sup>2</sup> ) <sup>2</sup> / Hz ( 5 ~ 20 Hz ) -6dB / octave ( 20 ~ 150 Hz )

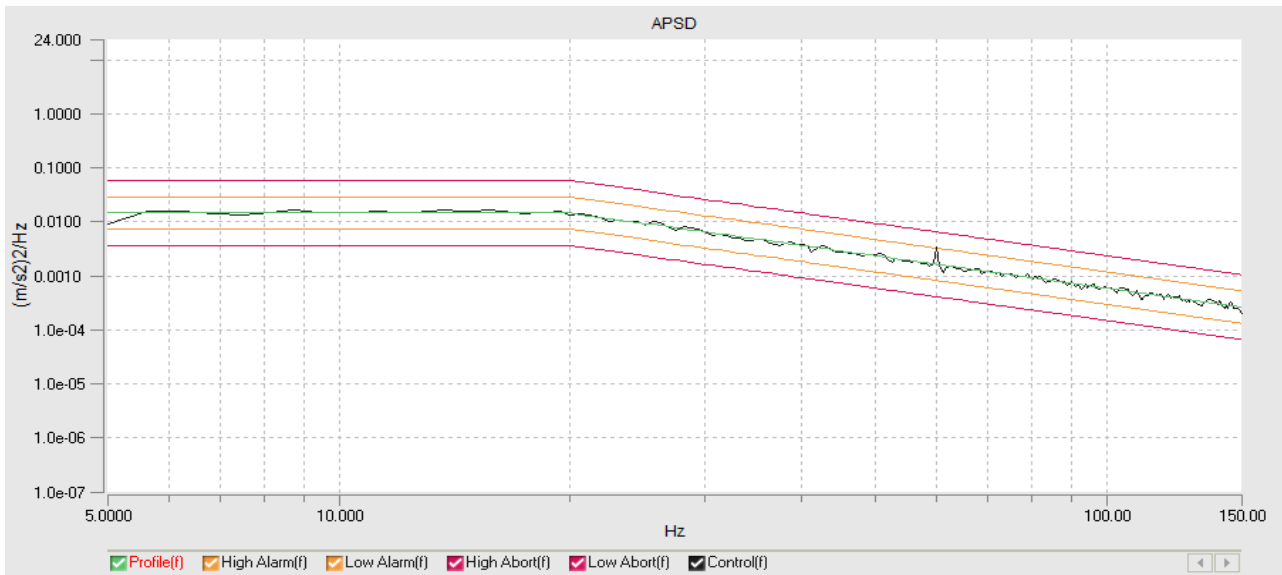
FIG 2.1: X axis test screen

Demand RMS: 0.700 m/s<sup>2</sup>

Control RMS: 0.702 m/s<sup>2</sup>

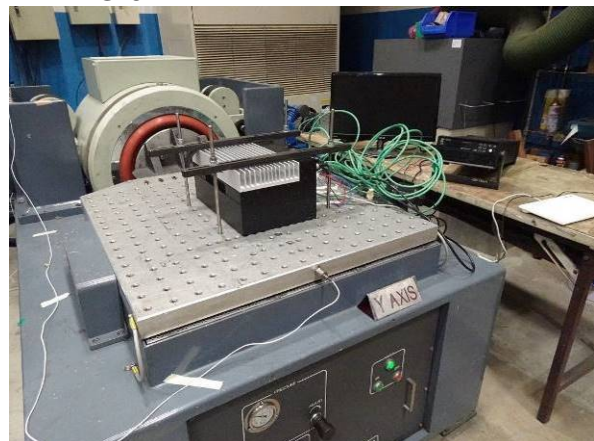
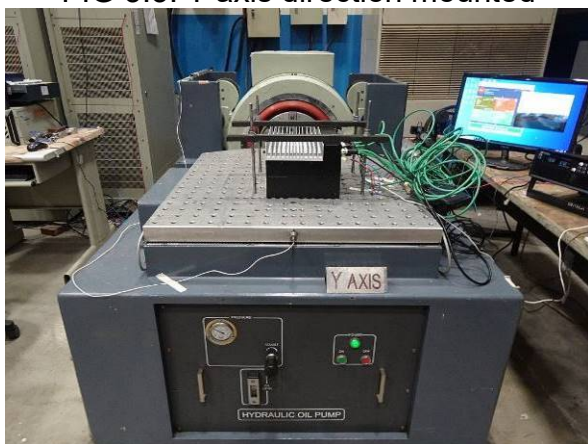
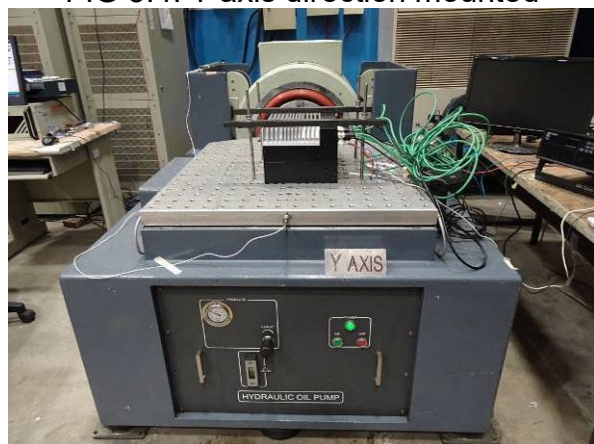
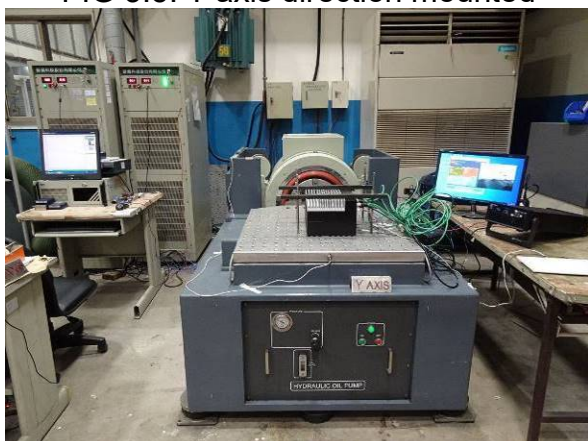
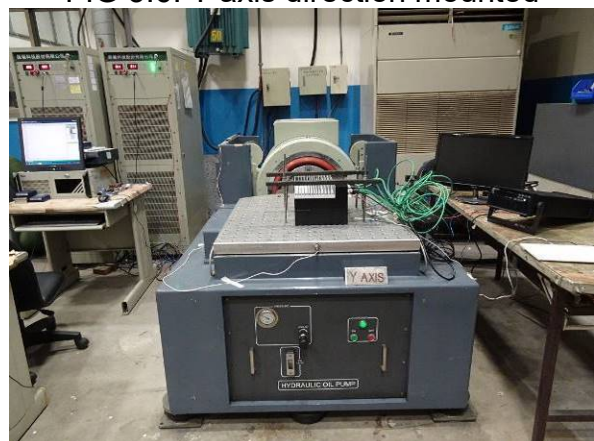
FIG 3.1: Y axis direction mounted

FIG 3.2: Y axis direction mounted

FIG 3.3: Y axis direction mounted

FIG 3.4: Y axis direction mounted

FIG 3.5: Y axis direction mounted

FIG 3.6: Y axis direction mounted

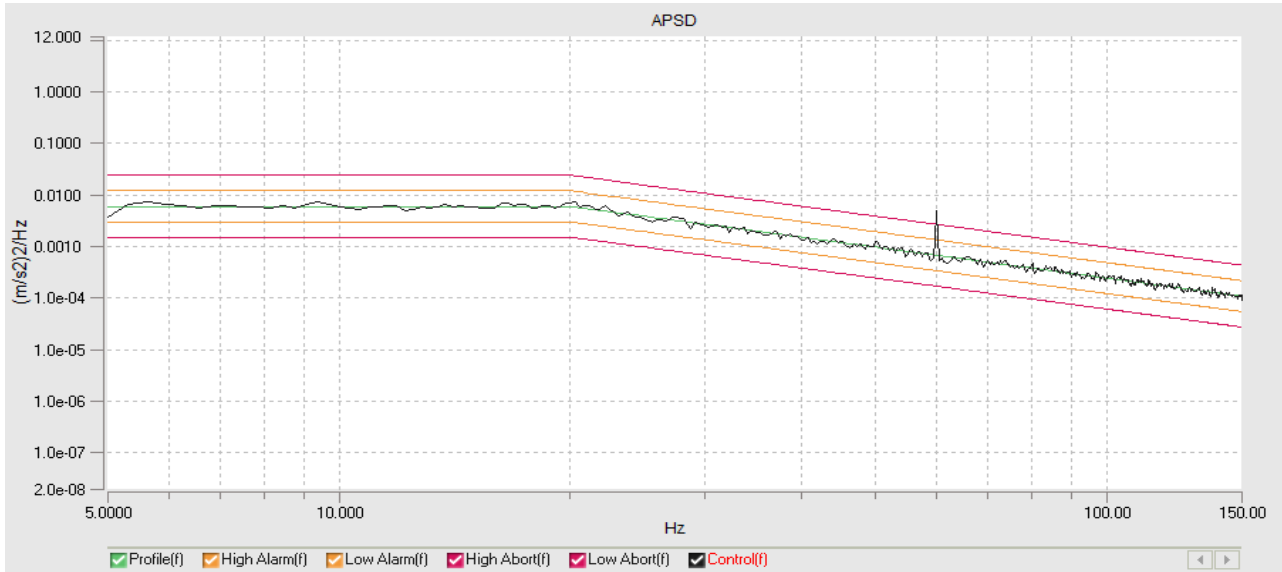
FIG 4.1: Y axis test screen

Demand RMS: 0.450 m/s<sup>2</sup>

Control RMS: 0.451 m/s<sup>2</sup>

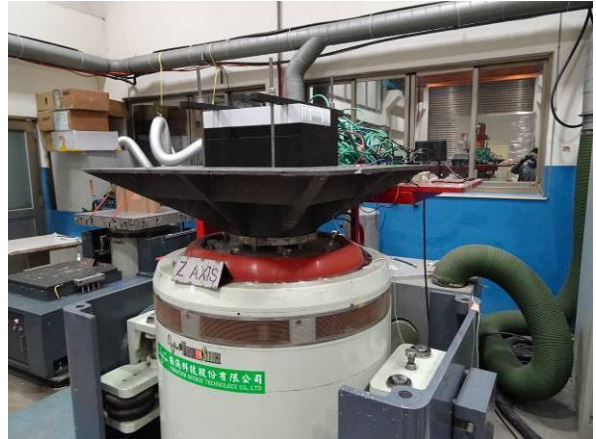
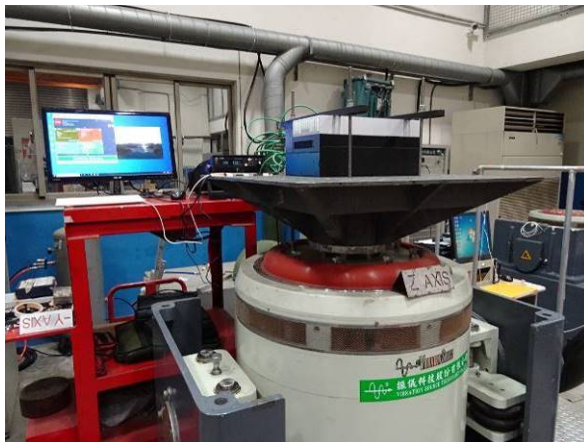
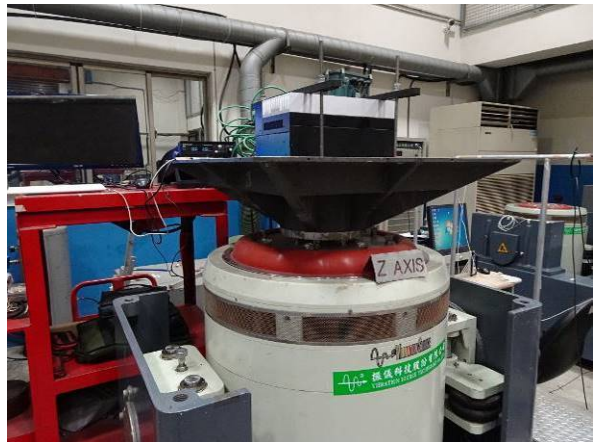
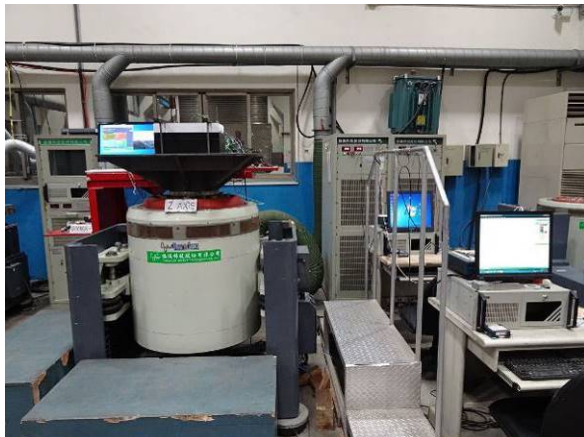
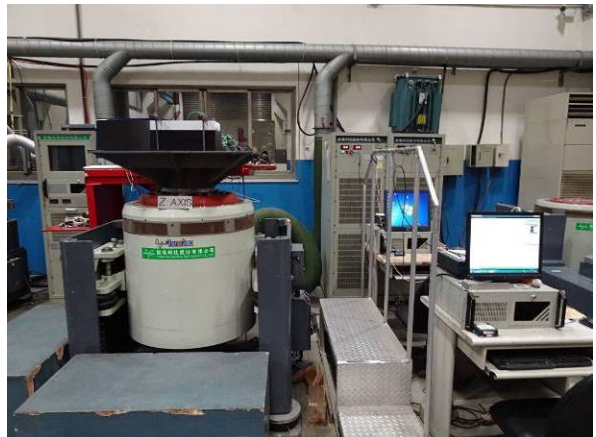
FIG 5.1: Z axis direction mounted

FIG 5.2: Z axis direction mounted

FIG 5.3: Z axis direction mounted

FIG 5.4: Z axis direction mounted

FIG 5.5: Z axis direction mounted

FIG 5.6: Z axis direction mounted

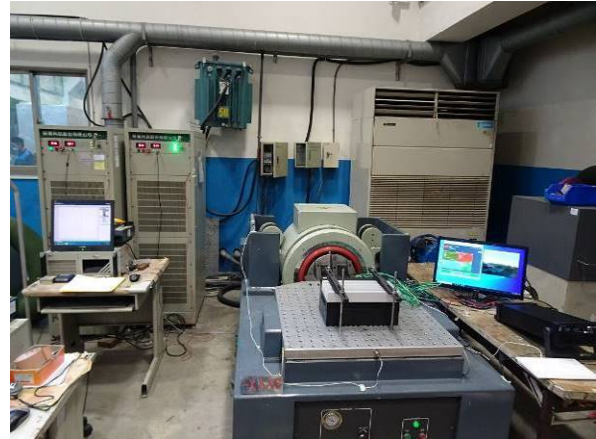
FIG 9.1: -X axis direction mounted

FIG 9.2: -X axis direction mounted

Test Item	Test 3 : Shock Test			
Test Condition	Waveform:	Half Sine Wave		
	Axial:	Vertical (Z Axis)	Transverse (Y Axis)	Longitudinal (X Axis)
	Shock	30 m/s <sup>2</sup>	30 m/s <sup>2</sup>	50 m/s <sup>2</sup>
	Peak Acceleration:			
	Duration Time :	30 ms	30 ms	30 ms
	Vibration Axial:	3 Axis , 6 Faces		
	Shock Time:	3 times		
	Total Time:	18 times		
	FIG 7.1 ~ 7.2:	+X axis direction mounted		
	FIG 8:	+X axis test screen		
	FIG 9.1 ~ 9.2:	-X axis direction mounted		
	FIG 10:	-X axis test screen		
	FIG 11.1 ~ 11.2:	+Y axis direction mounted		
	FIG. 12:	+Y axis test screen		
	FIG 13.1 ~ 13.2:	-Y axis direction mounted		
	FIG 14:	-Y axis test screen		
	FIG 15.1 ~ 15.2:	+Z axis direction mounted		
	FIG 16:	+Z axis test screen		
	FIG 17.1 ~ 17.2:	-Z axis direction mounted		
	FIG 18:	-Z axis test screen

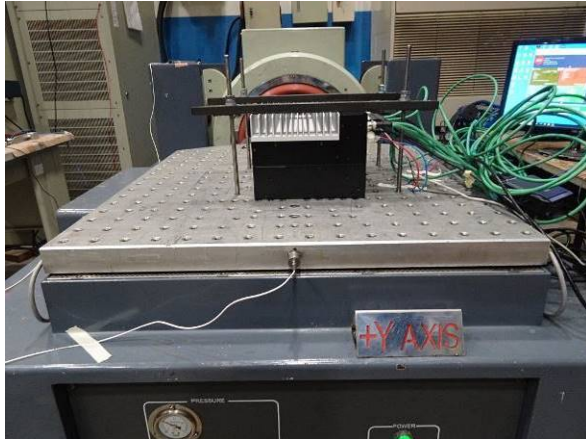
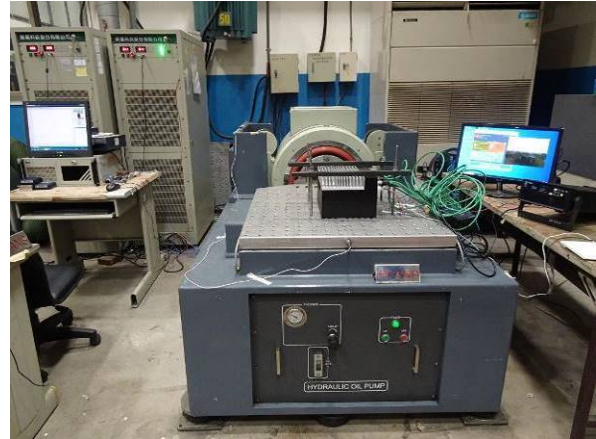
FIG 11.1: +Y axis direction mounted

FIG 11.2: +Y axis direction mounted

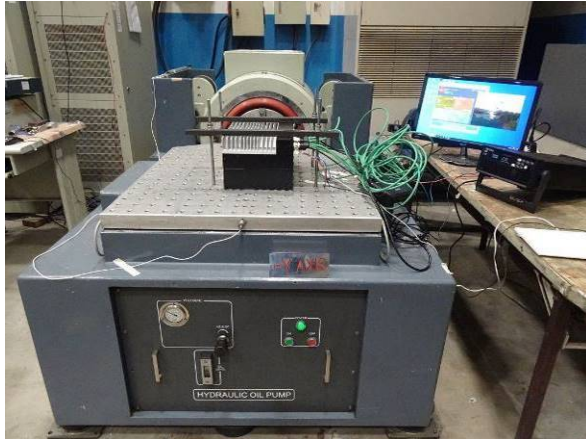
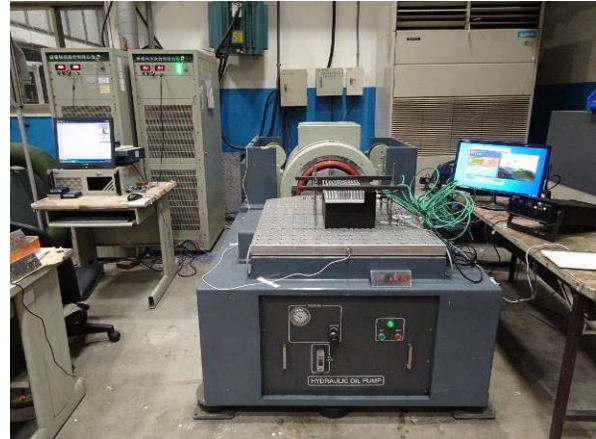
FIG 13.1: -Y axis direction mounted

FIG 13.2: -Y axis direction mounted

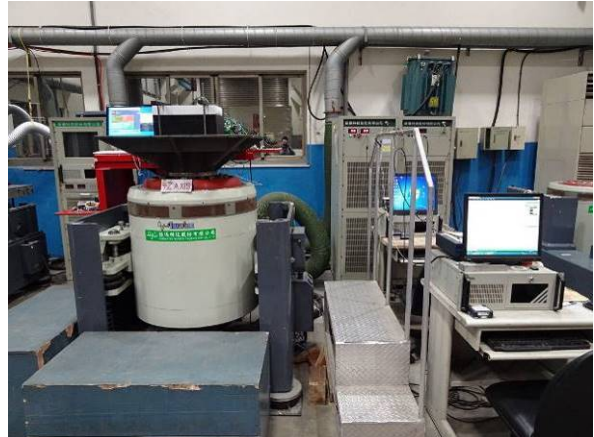
FIG 15.1: +Z axis direction mounted

FIG 15.2: +Z axis direction mounted

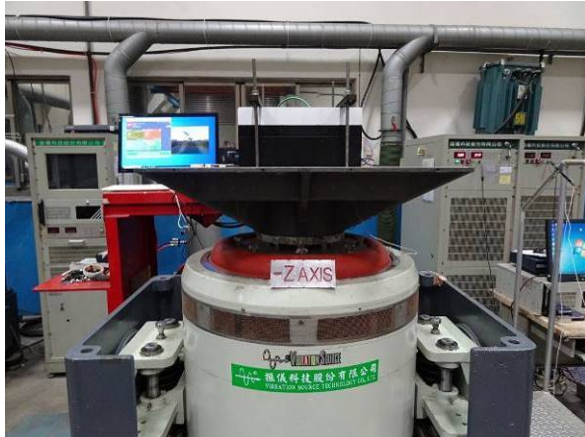
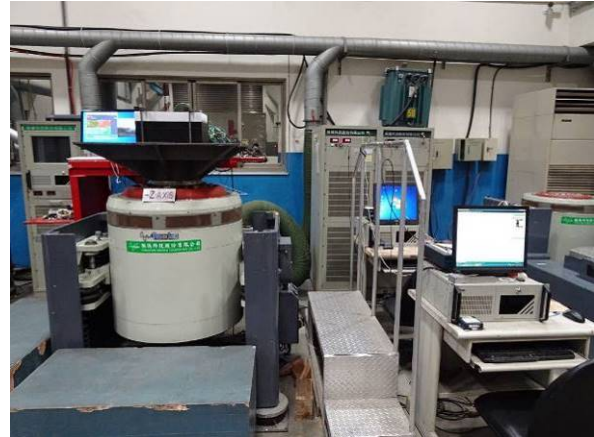
FIG 17.1: -Z axis direction mounted

FIG 17.2: -Z axis direction mounted
