TEST REPORT Environmental Testing MIL-STD-810H: 2019, Method 514.8, Procedure I – General Vibration MIL-STD-810H: 2019, Method 516.8, Procedure I – Functional Shock	
Report Number	2506011
Date of issue	2025/07/07
Total number of pages	11
Tested by (name, function, signature)	Ellis Yu / Engineer
Approved by (name, function, signature).....	David Wang / Reviewer

Test Result	No visible Damage and Functional check Normal

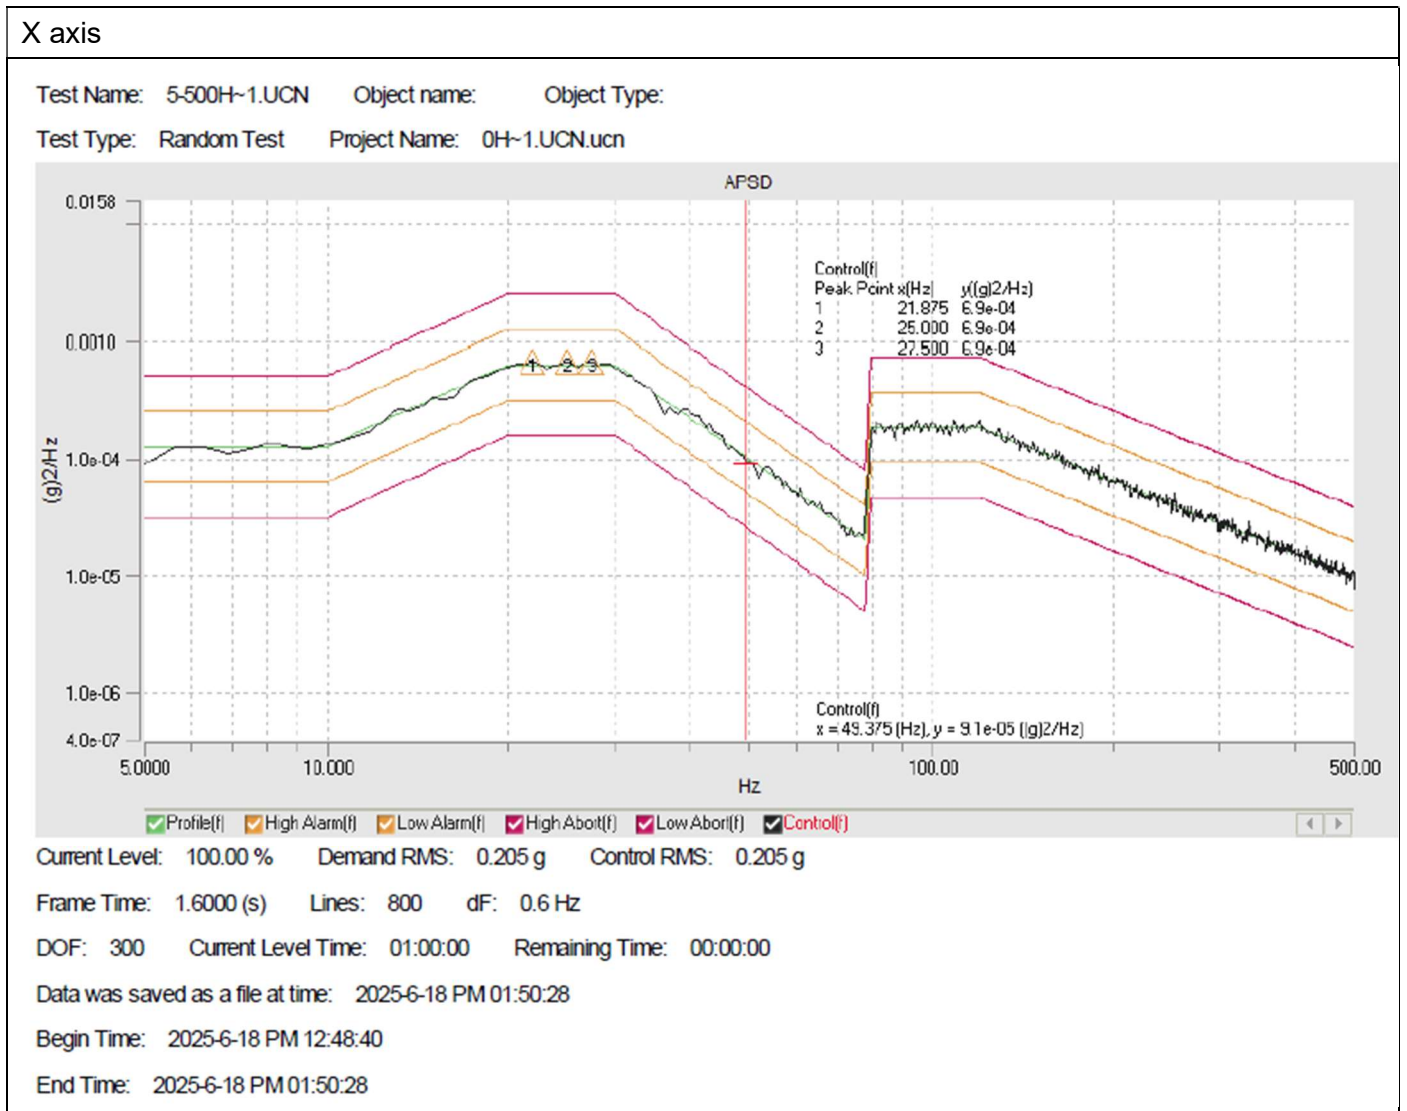
500	0.00015	20	0.00065	120	0.0002		
		30	0.00065	121	0.003		
		78	0.00002	200	0.003		
		79	0.00019	240	0.0015		
		120	0.00019	340	0.00003		
		500	0.00001	500	0.00015		
→Equivalent to 1.08 Grms		→Equivalent to 0.21 Grms		→Equivalent to 0.76 Grms			
Direction : X, Y, Z axis (See photo 1 ~ 3)							
Duration : 1 hour/ axis							
Test Procedure:							
<ul style="list-style-type: none"> - Check the samples' appearance before the test. - Install the samples on the testing table and set up testing condition. - After testing, take off samples from table and put them in the storage area. - Observe the samples and record for any visible change after testing. 							
Summary:							
<ul style="list-style-type: none"> - No visible damage was found on sample appearance after the test. - Sample photo after the test:

Test profile:

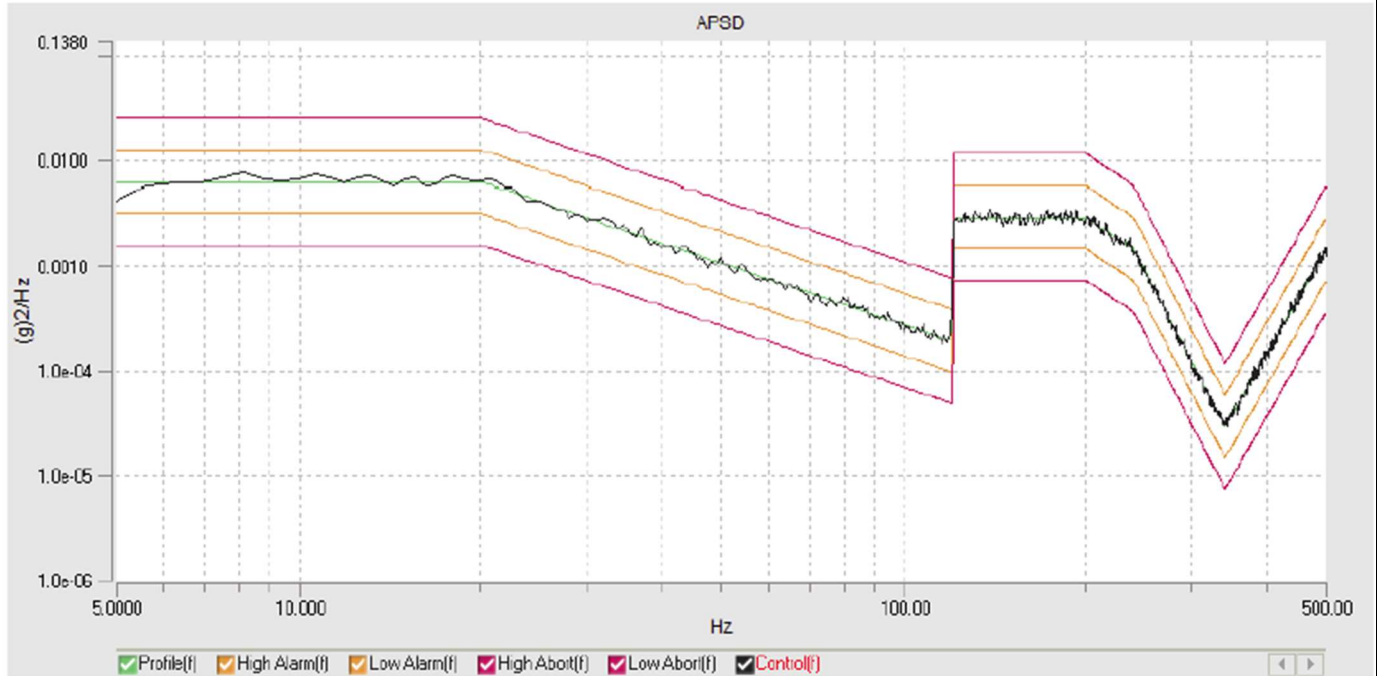
Y axis

Current Level: 100.00 % Demand RMS: 0.796 g Control RMS: 0.797 g

Frame Time: 1.6000 (s) Lines: 800 dF: 0.6 Hz

DOF: 300 Current Level Time: 01:00:00 Remaining Time: 00:00:00

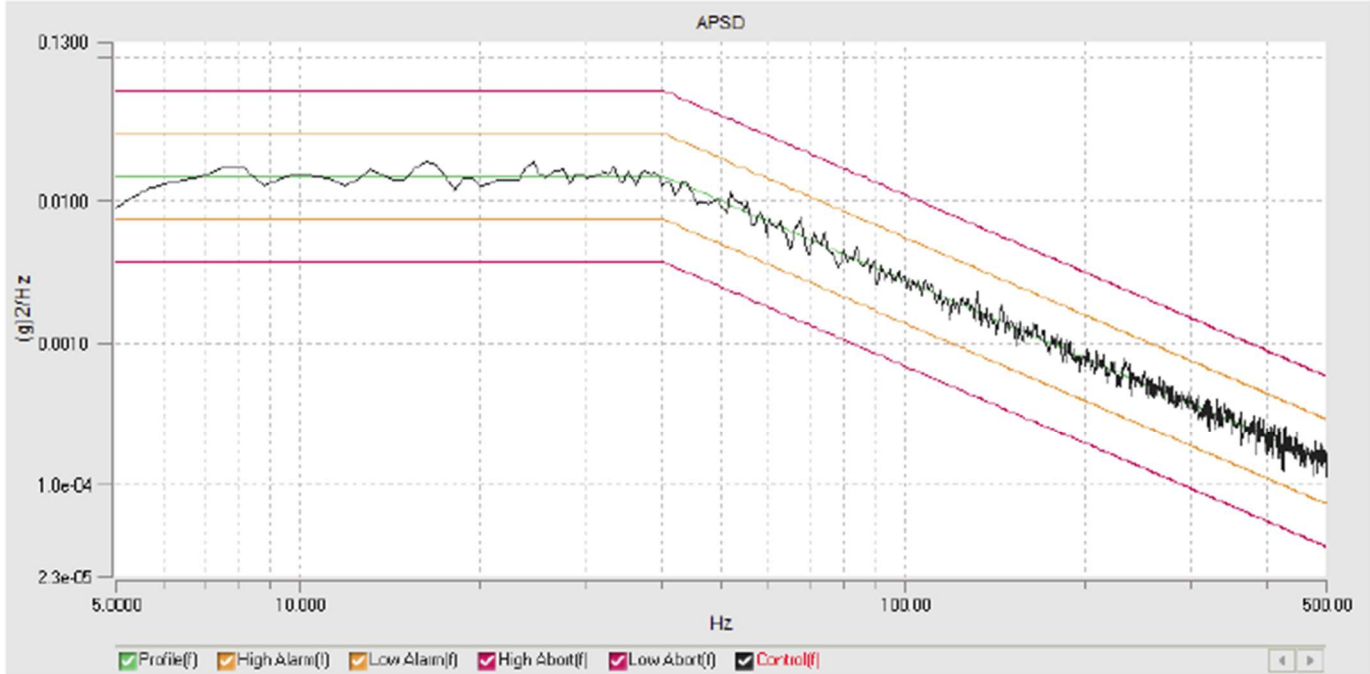
Z axis

Current Level: 100.00 % Demand RMS: 1.078 g Control RMS: 1.072 g

Frame Time: 1.6000 (s) Lines: 800 dF: 0.6 Hz

DOF: 120 Current Level Time: 01:00:00 Remaining Time: 00:00:00

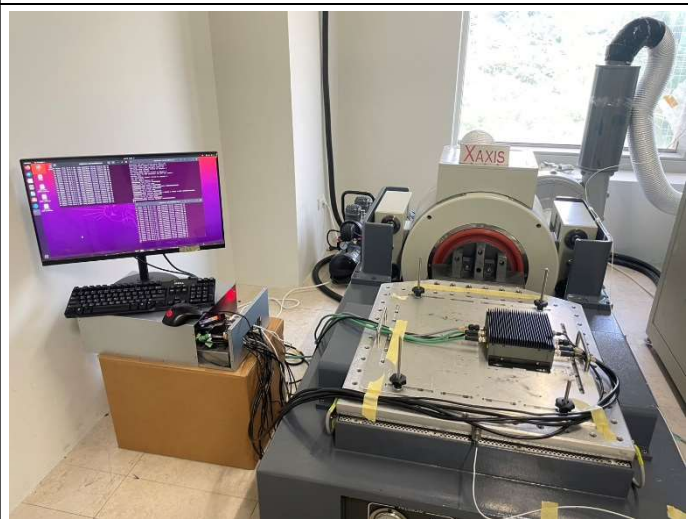
4. ±X axis

Summary:			
<ul style="list-style-type: none"> - No visible damage was found on sample appearance after the test. - Sample photo after the test:
